NONDESTRUCTIVE TESTING OF DIFFUSION BONDED TITANIUM  
ALLOYS FOR ENGINE AND AIRFRAME COMPONENTS

**AFML-TR-74-215**

*FORT WORTH DIVISION  
GENERAL DYNAMICS CORPORATION*

**AIR FORCE MATERIALS LABORATORY  
AIR FORCE SYSTEMS COMMAND  
WRIGHT-PATTERSON AIR FORCE BASE, OHIO 45433**

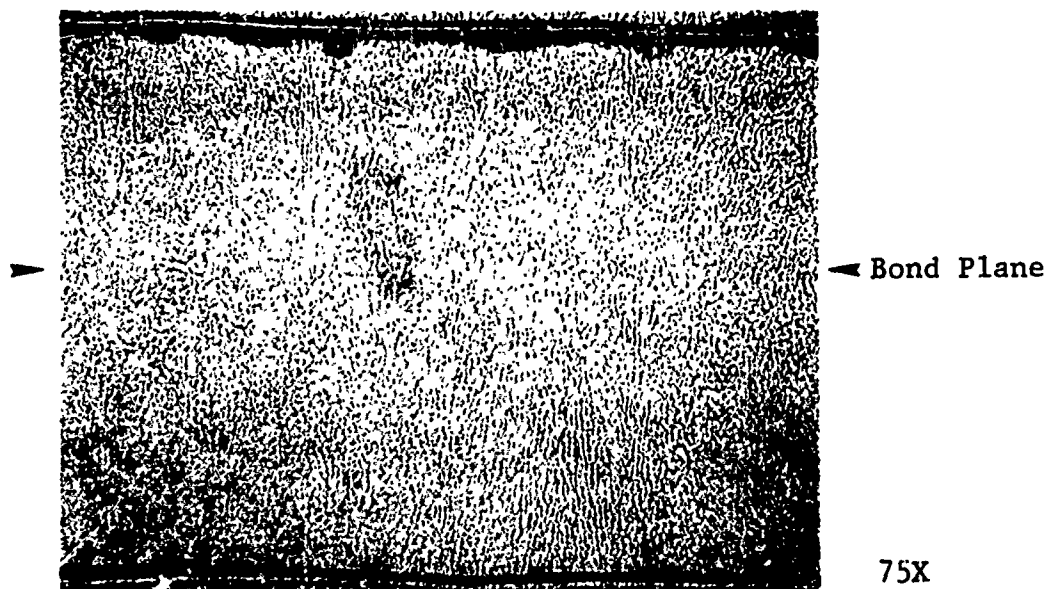
Figure 6.18 Photomicrographs at Bond Plane of DB Specimen B-3

Specimen C3, which was bonded under much less than optimum bonding conditions (1½% deformation), showed large areas of non-bonding after the bonding cycle. Specimen B3, which had 2½% deformation, contains only one small area where bonding did not occur. No voids were found around the bonding area in specimens

Defect Type: Non-optimum bonding parameters (2½% deformation)

Comments: Bond area includes grain boundaries aligned with bond plane in localized areas. Unintentional void or inclusion visible.

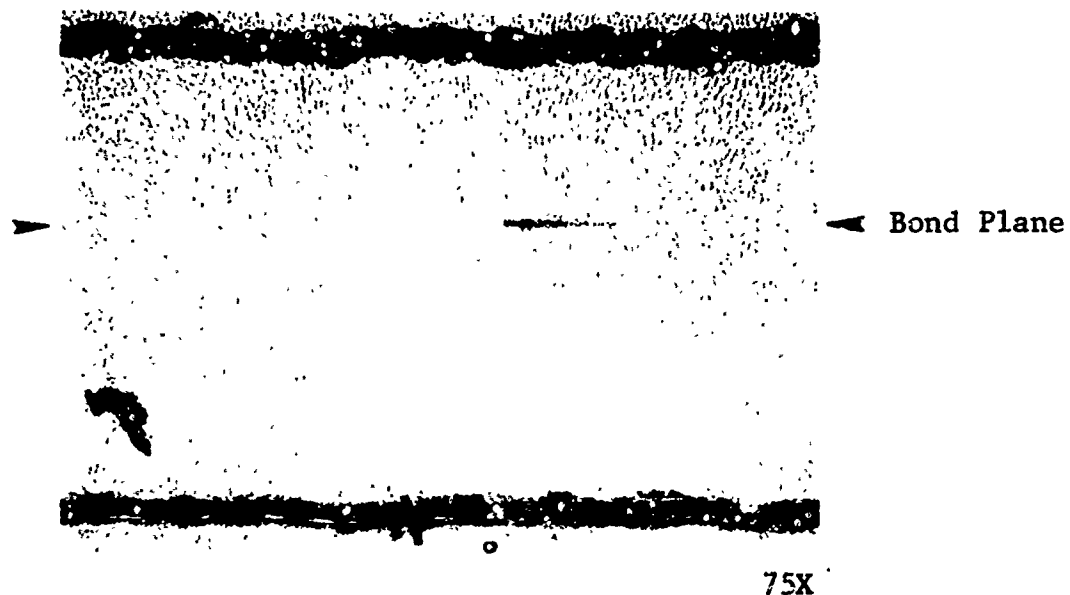
Figure 6.19 Photomicrographs at Bond Plane of DB Specimen C-3

Defect Type: Non-optimum bonding parameters (1½% deformation)

Comments: Little grain growth across the bond plane. Unbonded area indicating localized lack of contact between faying surfaces.

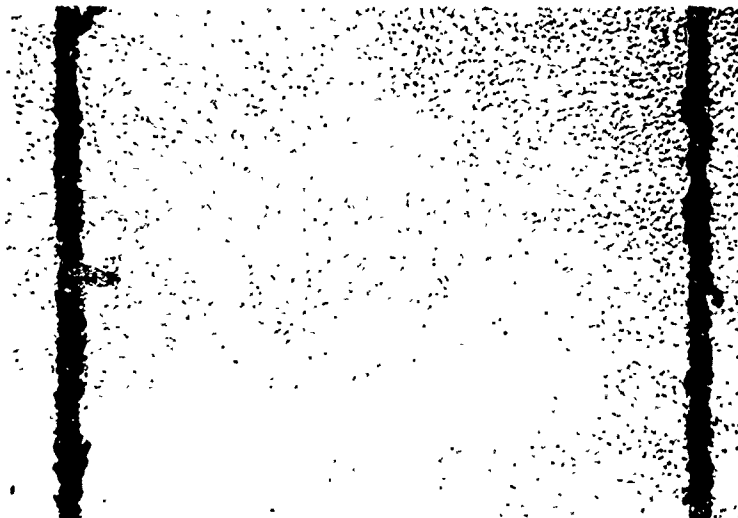
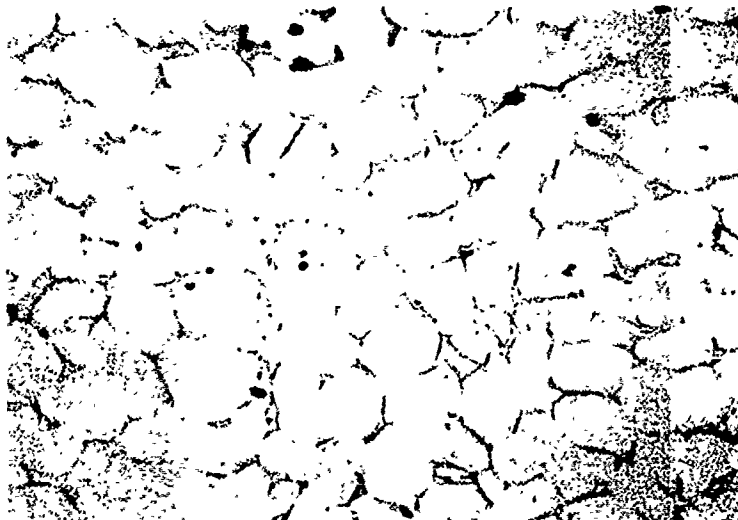
Defect Type: Grain size ASTM 9 and opposed rolling directions

Comments: Bondline largely indistinguishable. Preferred orientations appear to have disappeared. Very little change in primary alpha grain size due to bonding cycle.

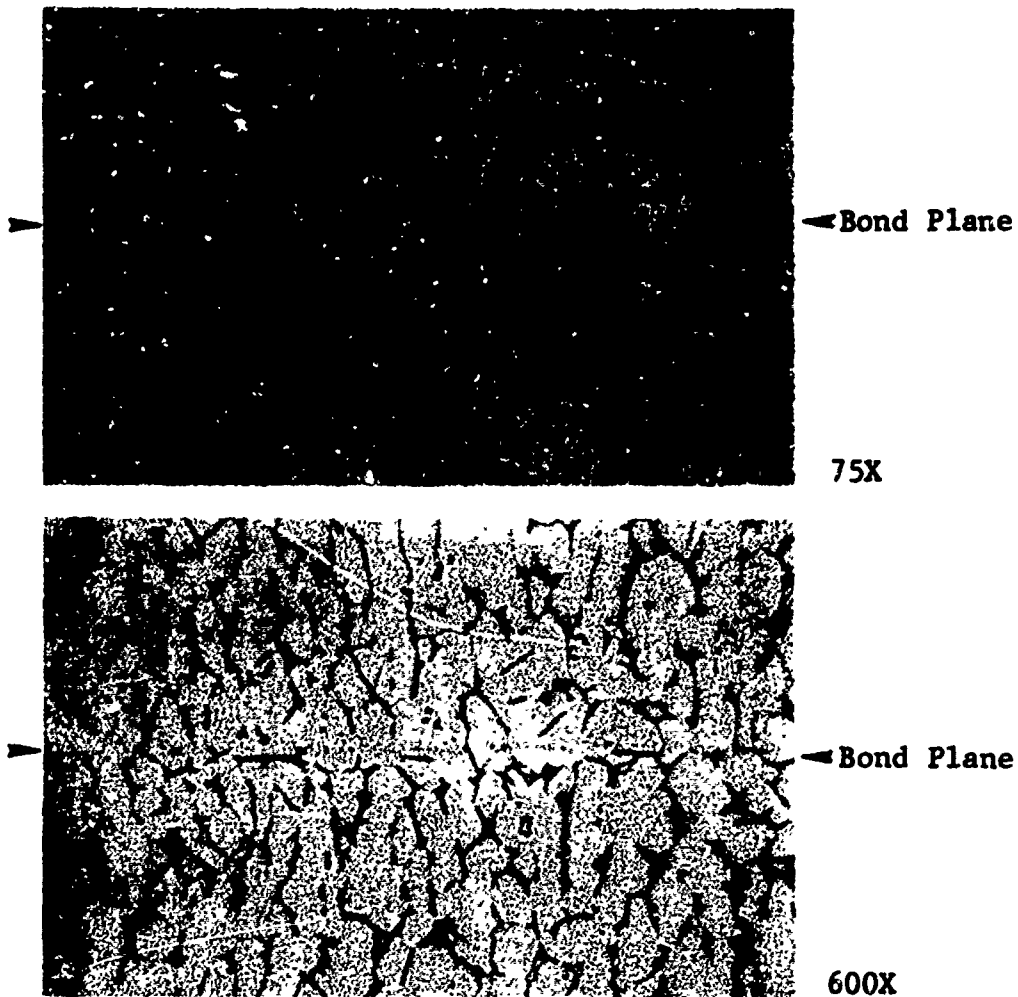
**Figure 6.24 Photomicrographs at Bond Plane of DB Specimen J-4**

**Bonding Parameters:** 1700°F, 6 Hrs, 7% Deformation  
**Defect Type:** Alpha case layer  
**Dimensions:** Before bonding - 0.187" dia. x 0.002" thick  
After bonding - (see comments)

**Comments:** Diffusion of the oxygen & nitrogen away from the bond plane resulted in a partial loss of identity of the original alpha case layer. Subgrain size features remain including microvoids and minute unbonded areas aligned with the original bond plane. Effects on the adjacent microstructure are visible. Microhardness measurements transverse to the bondline after bonding indicate a hardness maxima at the bondline of 486 KHN. The hardness decreases slowly as a function of depth below the bondline. A distance of 0.035" is required before the microhardness reaches a value typical of heat-treated parent material (350 KHN).

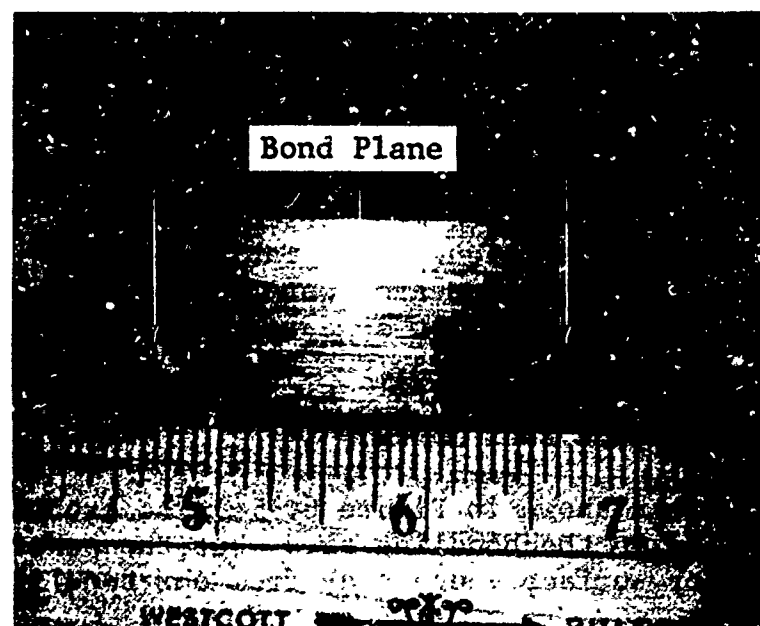
Figure 6.33 Blue Etch-Anodize Records of Specimens J5 and V6-A

In the multiple bond/three axes specimens, color discontinuities were again most prevalent in the alpha case specimen V6-A. The discontinuities observed for the bond plane lying in the long transverse direction are shown in Figure 6.33b. In some specimens, bond lines were only observed in small areas. The location of these areas are described in the tables.

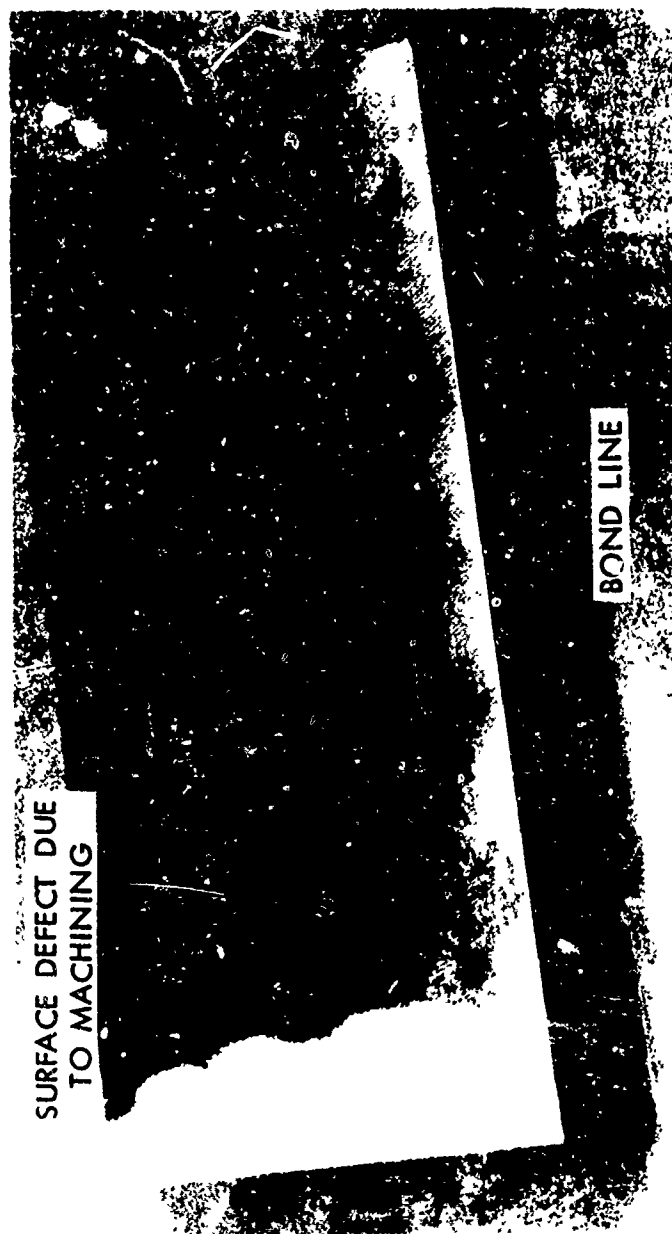
Figure 6.35 Fluorescent Penetrant Record of Diffusion Bonded Titanium Specimen with Surface Gouge

The specimen shown in Figure 6.35 also exhibits no discontinuities in the bondline area, but the penetrant did pick up a minor surface gouge away from the bondline.

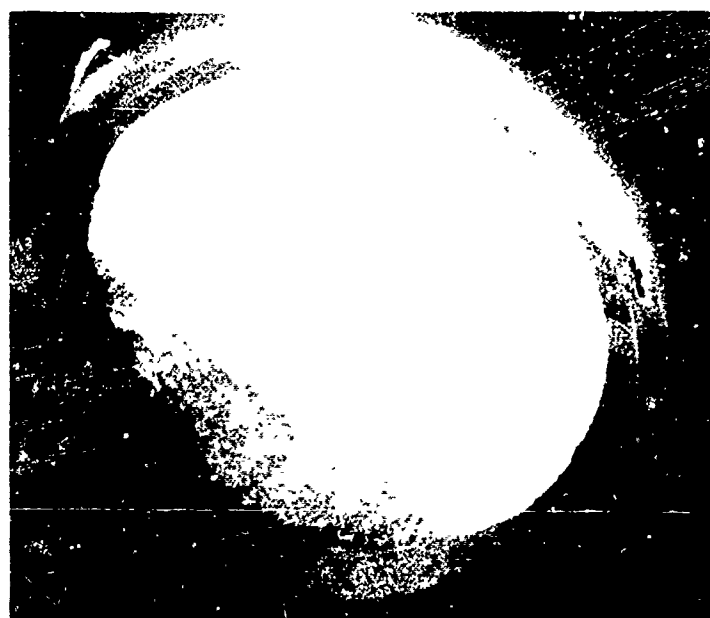
(b) D2-1, 1" Plate, Heated at 1700°F for 6 Hours,  
Furnace Cooled

Figures 8.9 and 8.10 show low-magnification scanning electron micrographs of four fracture surfaces of 6-4 titanium representing four different thermal histories. Figure 8.9(a) depicts material from the 1" plate in the as-received condition. Figures 8.9(b), 8.10(a), and 8.10(b) show the fracture topography for material which had held for 6 hours at temperatures of 1700, 1735, and 1775°F, respectively. Although the as-received material shows a somewhat more irregular surface than the heat-soaked specimen, the basic texture is evident in all the specimens. The higher magnification (1000X) photomicrographs of Figures 8.11(a) and 8.11(b) show the mode of fracture to be primarily void coalescence for both the unheated material and the material which had been subjected to the highest temperature. The texture of the fracture network is coarser in the latter material than in the former. The two intermediate heat-soaking temperatures produced fracture networks which were intermediate to these two extremes in coarseness.

Figure 8.9 Scanning Electron Micrographs of Two Ti-6Al-4V Fracture Surfaces with Different Thermal Histories (10X)

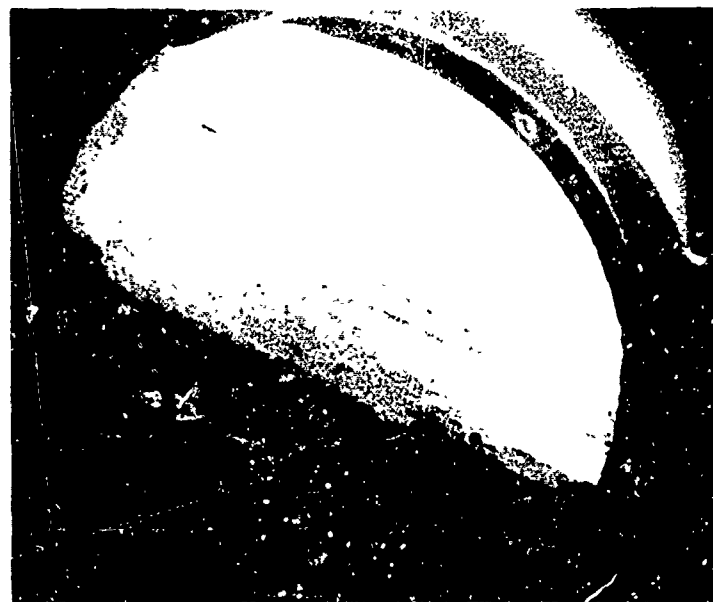
Figure 8.10 Scanning Electron Micrographs of Two Ti-6Al-4V Fracture Surfaces with Different Thermal Histories (10X)

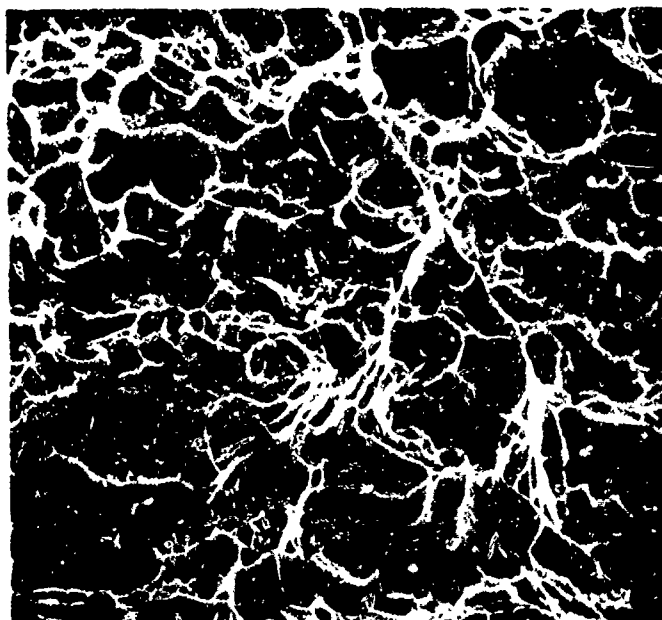
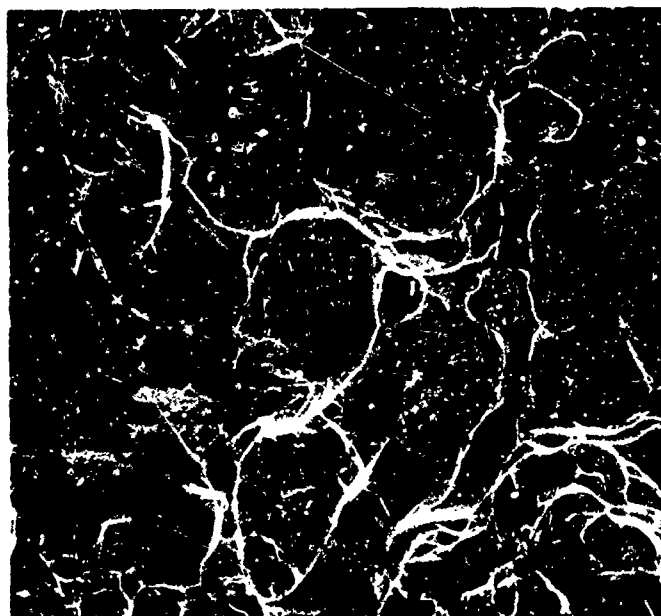
Figures 8.11 and 8.12 show the fracture topography for diffusion bonded specimens containing good bonds. The effect due to different primary alpha grain sizes between specimens, P4A1 and R4A3 on the texture of the fracture network can be observed in Figure 8.12. The texture is coarser in the larger grained material.

Figure 8.11 Scanning Electron Micrographs of Two Ti-6Al-4V Fracture Surfaces (1000X)

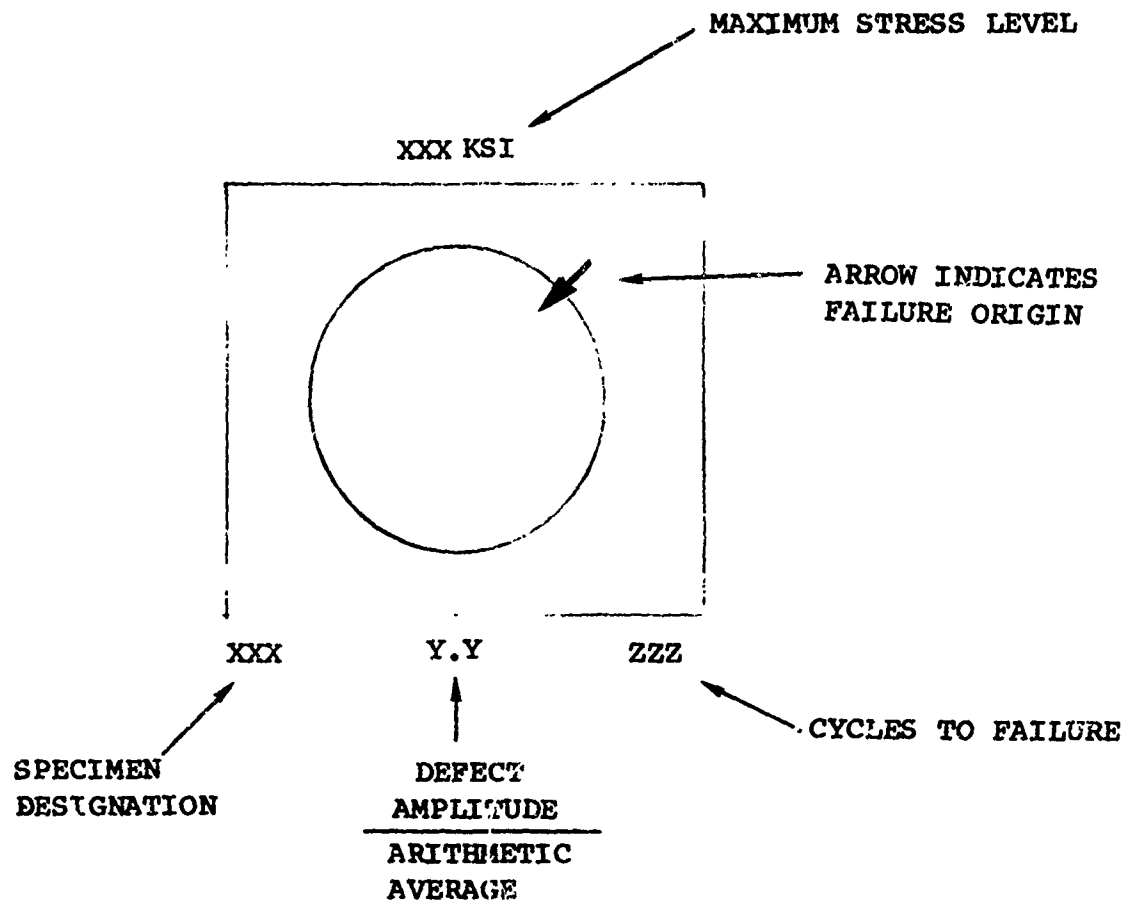
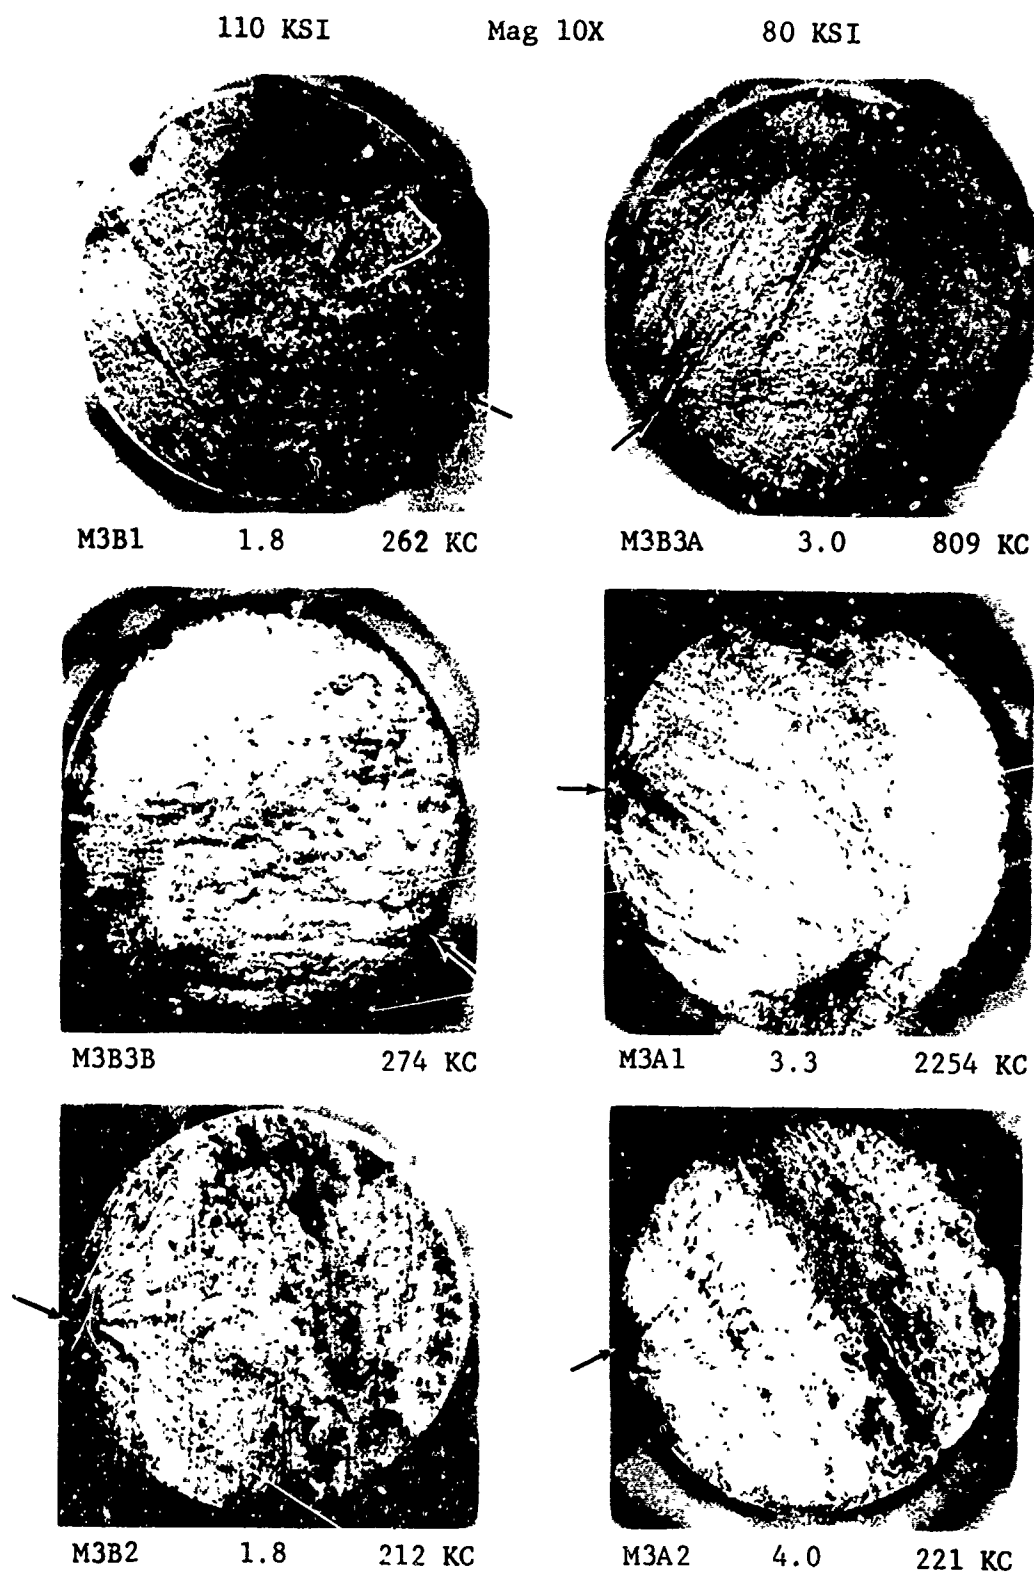
Figure 8.23 Fracture Surfaces of Failed Fatigue Specimens Series M3-Single Joint Optimum Diffusion Bonded with No Intentional Defects

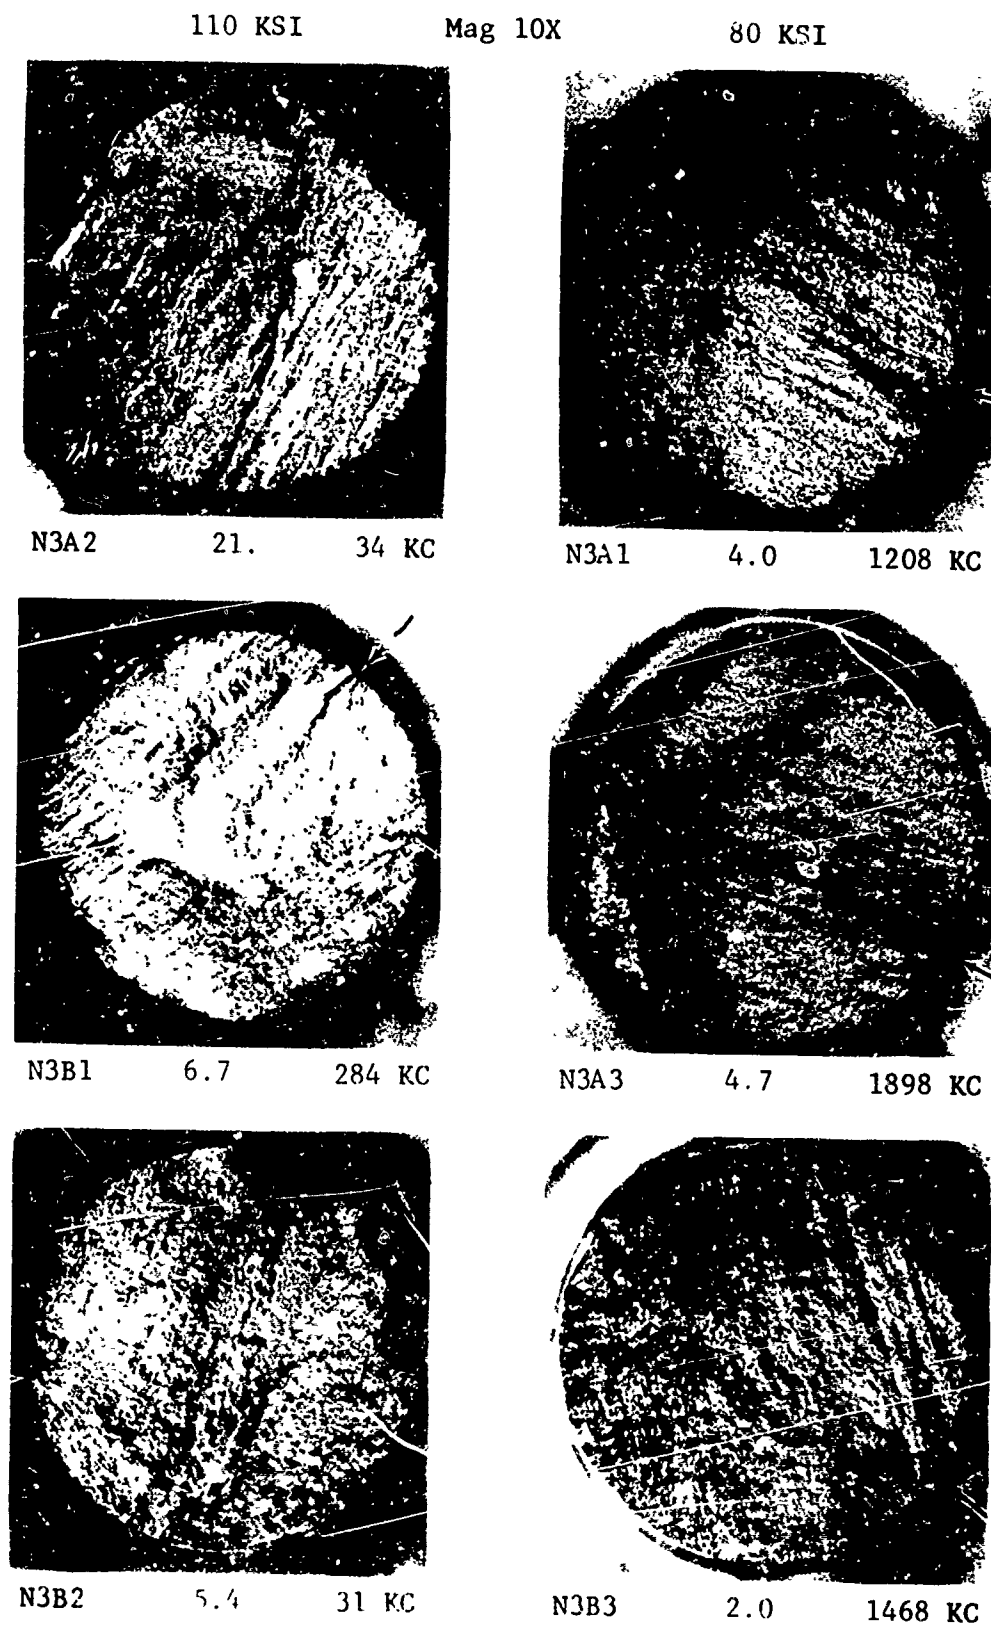
Figure 8.24 Fracture Surfaces of Failed Fatigue Specimens Series N3-  
Single Joint Diffusion Bonded with 2.7% Deformation

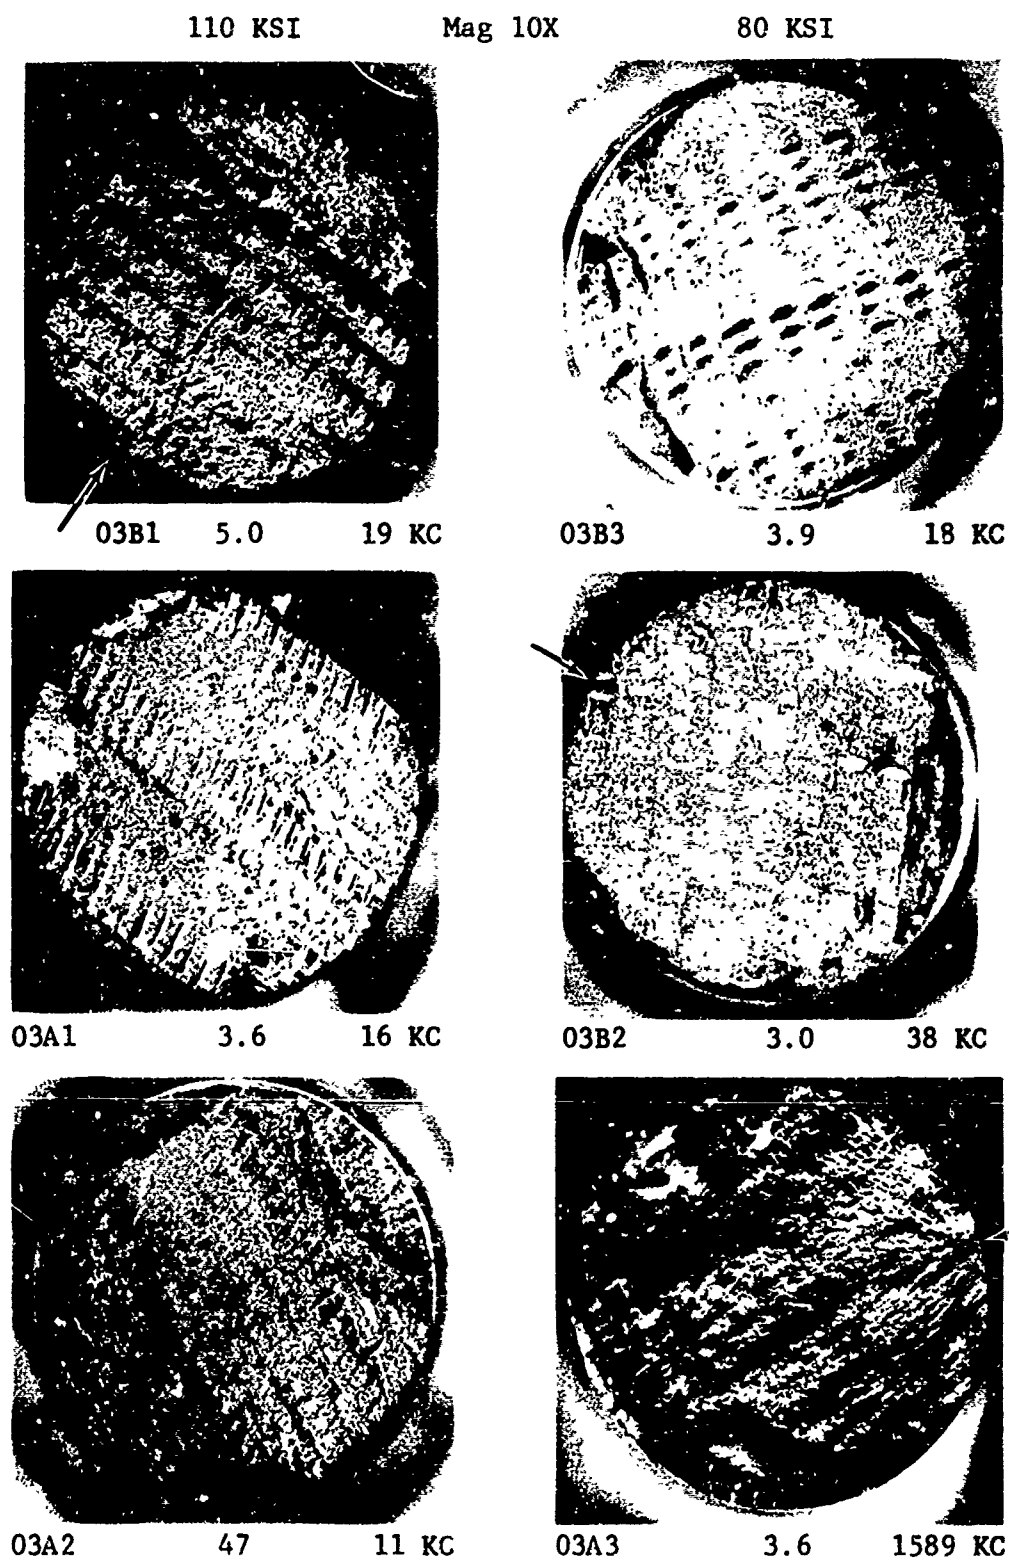
Figure 8.25 Fracture Surfaces of Failed Fatigue Specimens Series 03-  
Single Joint Diffusion Bonded with 1.5% Deformation

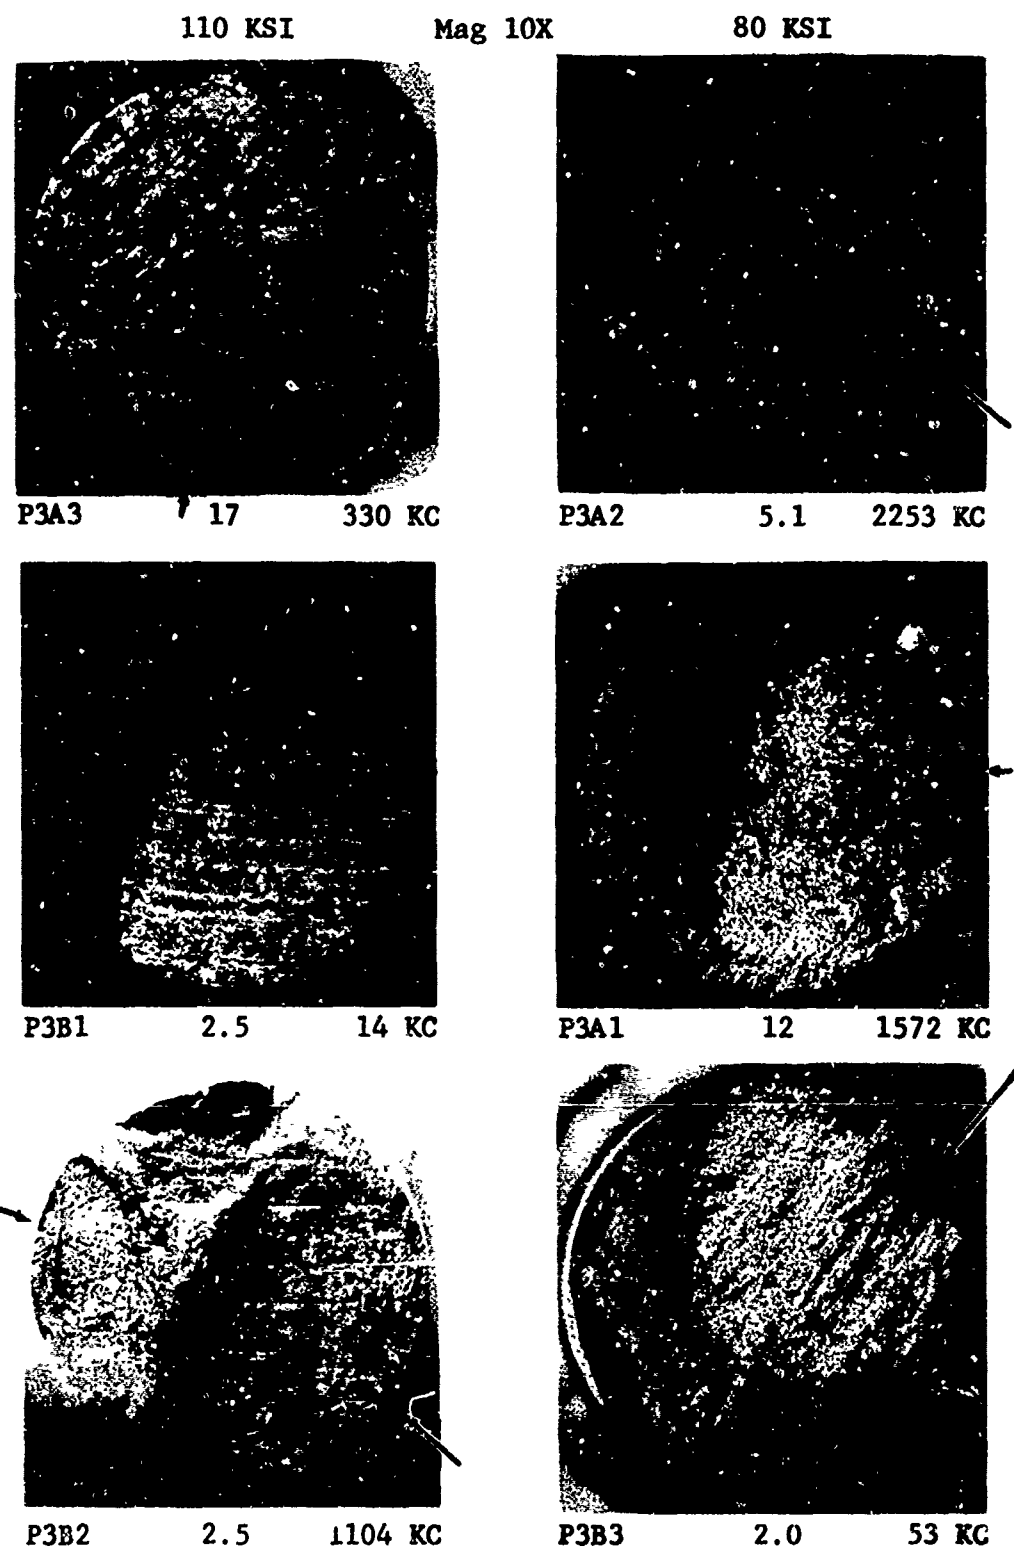
Figure 8.26 Fracture Surfaces of Failed Fatigue Specimens Series P3-  
Single Joint Diffusion Bonded - ASTM Grain Size No. 10

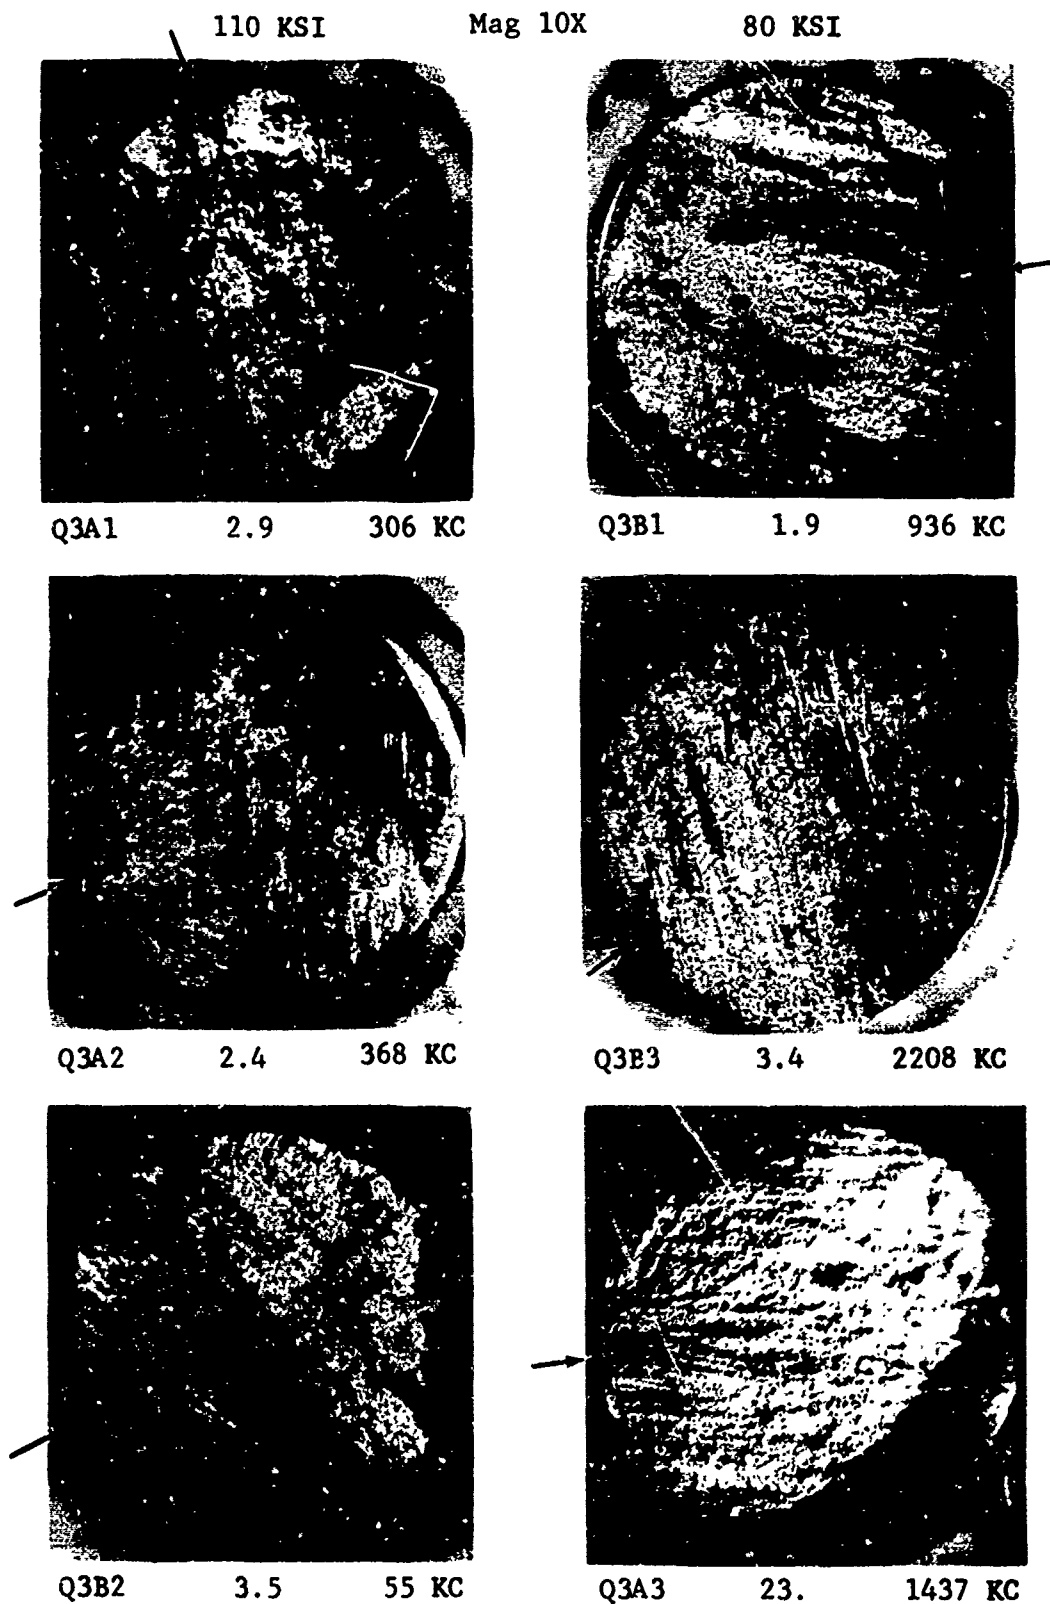
Figure 8.27 Fracture Surfaces of Failed Fatigue Specimens Series Q3-  
Single Joint Diffusion Bonded - ASTM Grain Size No. 9

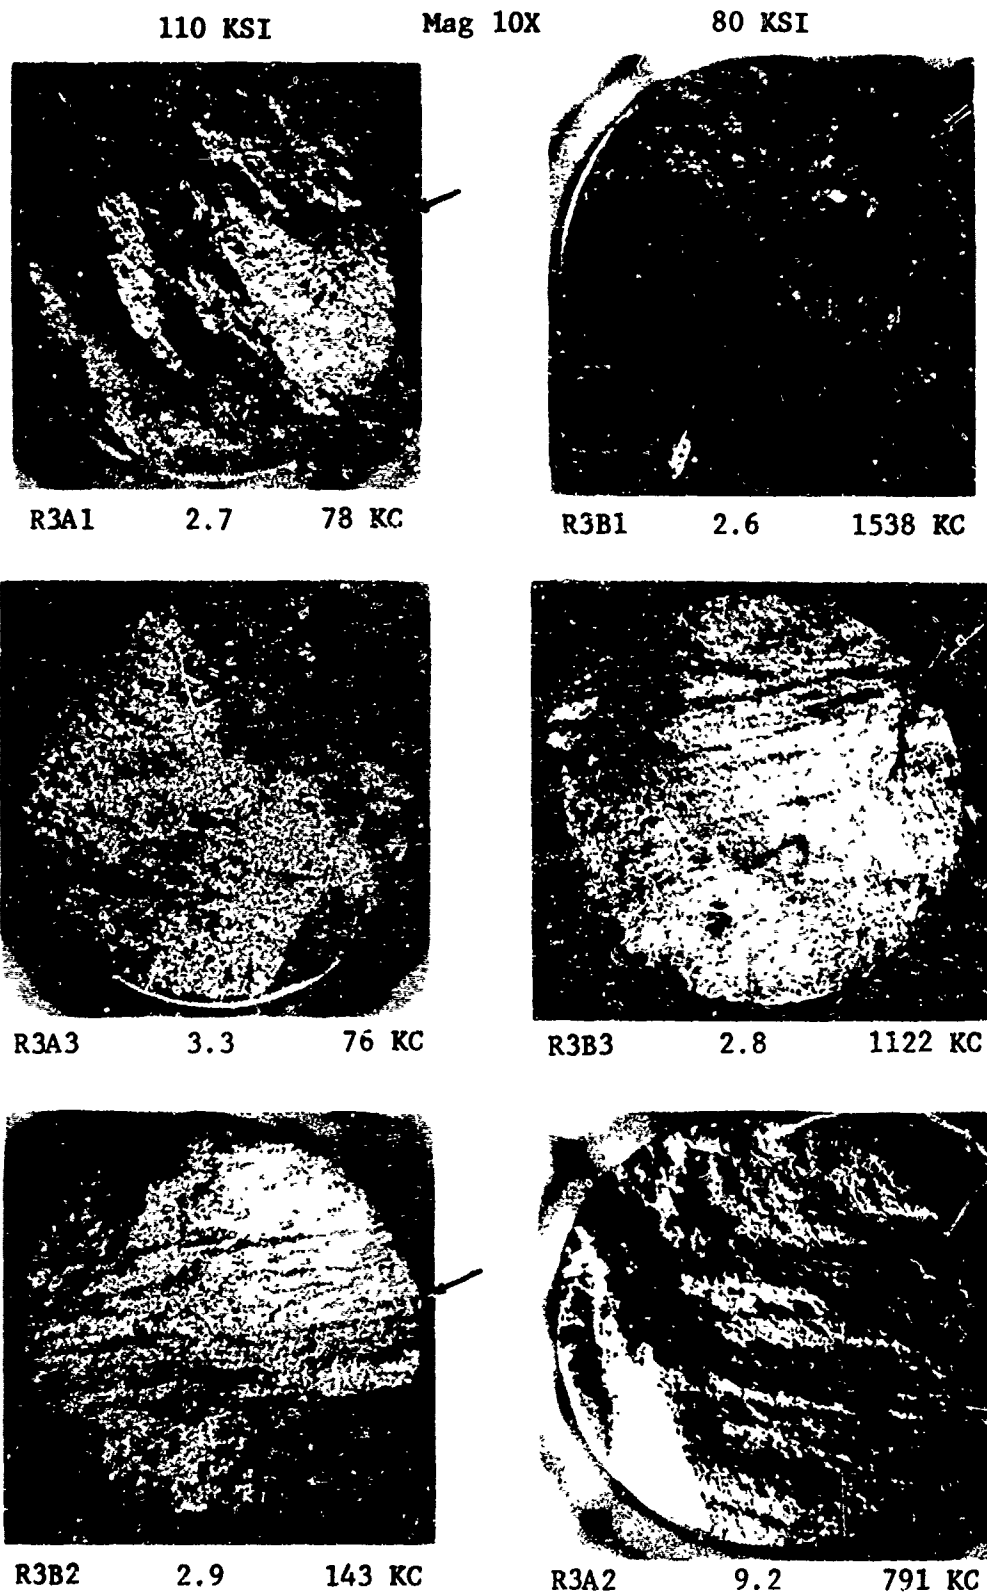
Figure 8.28 Fracture Surfaces of Failed Fatigue Specimens Series R3-  
Single Joint Diffusion Bonded - ASTM Grain Size No. 7.5

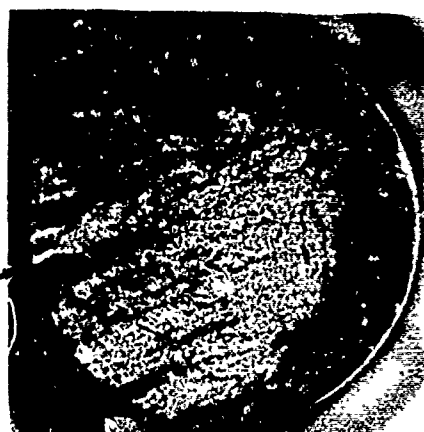
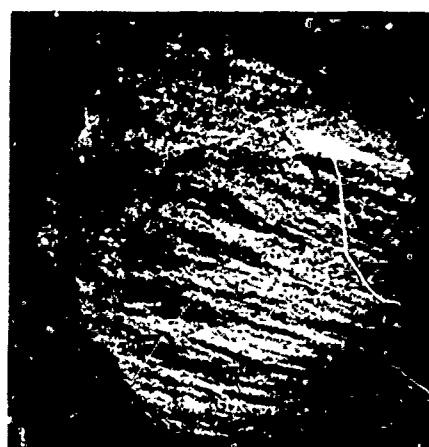
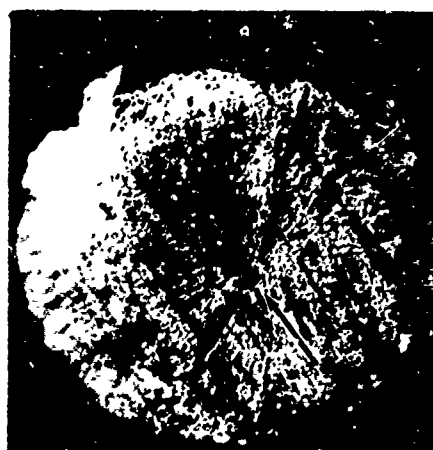
Figure 8.29 Fracture Surfaces of Failed Fatigue Specimens Series S3-  
Single Joint Diffusion Bonded with .0065" Dia. Surface Void

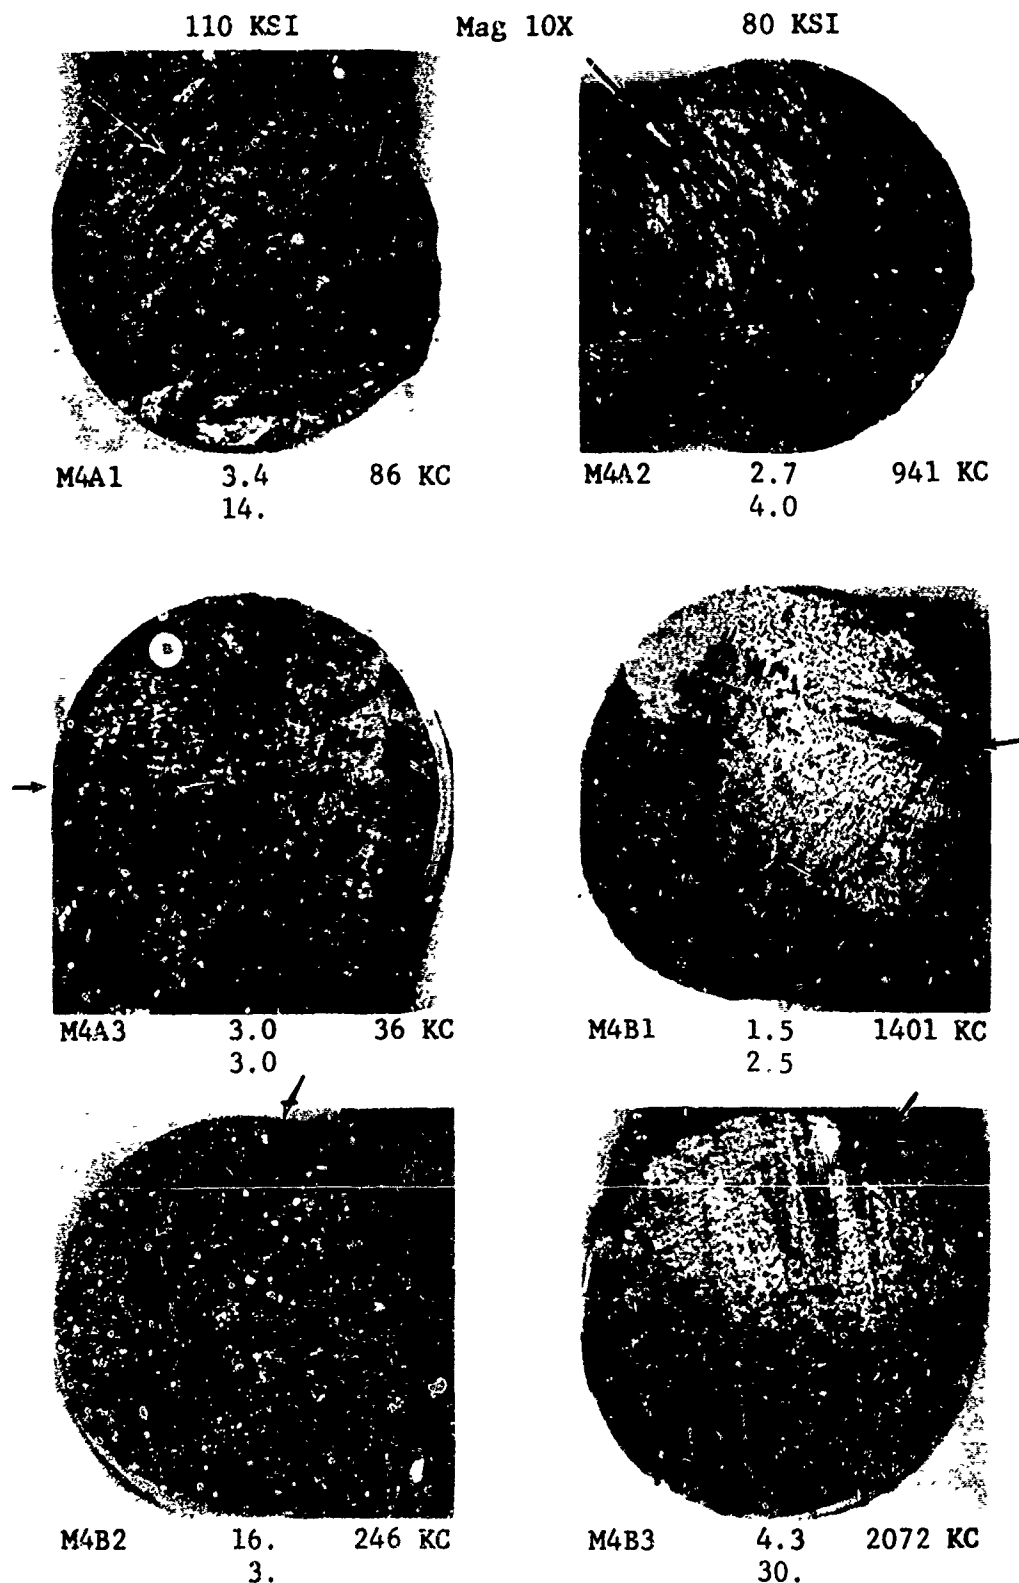
Figure 8.35 Fracture Surfaces of Failed Fatigue Specimens Series M4-Double-Bond/Single-Axis Diffusion Bonded with 7.5% Deformation

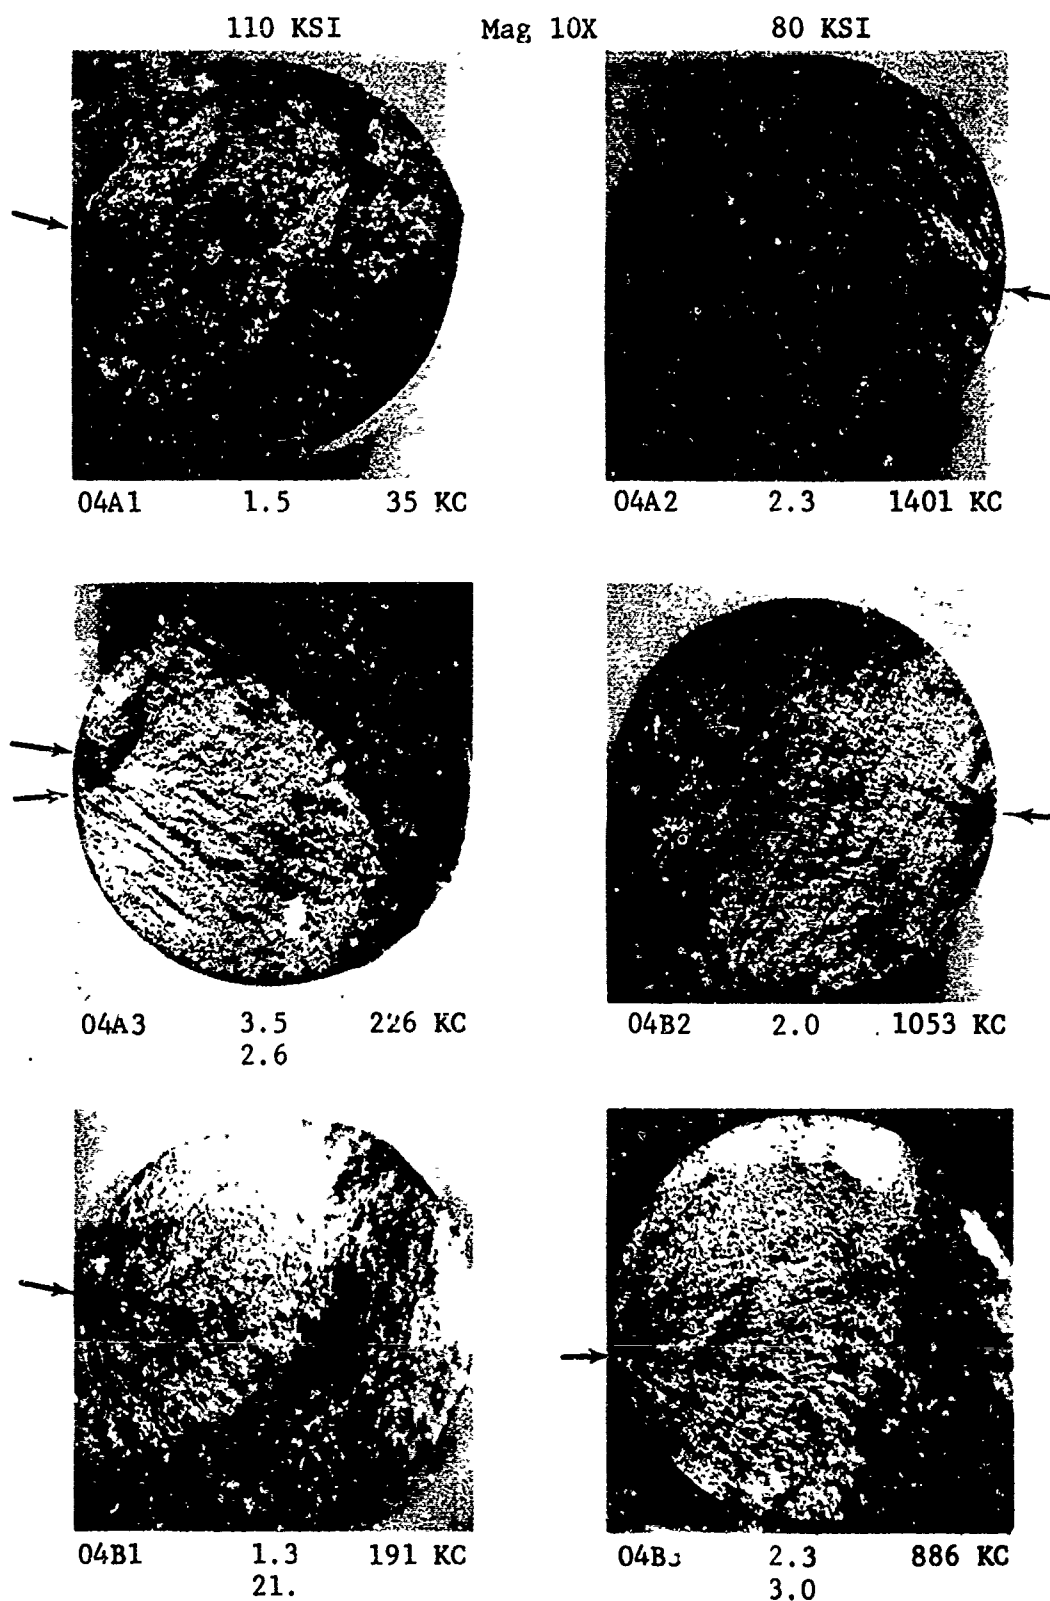
Figure 8.37 Fracture Surfaces of Failed Fatigue Specimens Series 04-Double-Bond/Single-Axis Diffusion Bonded with 1.5% Deformation
